Toyako Volcano Geopark

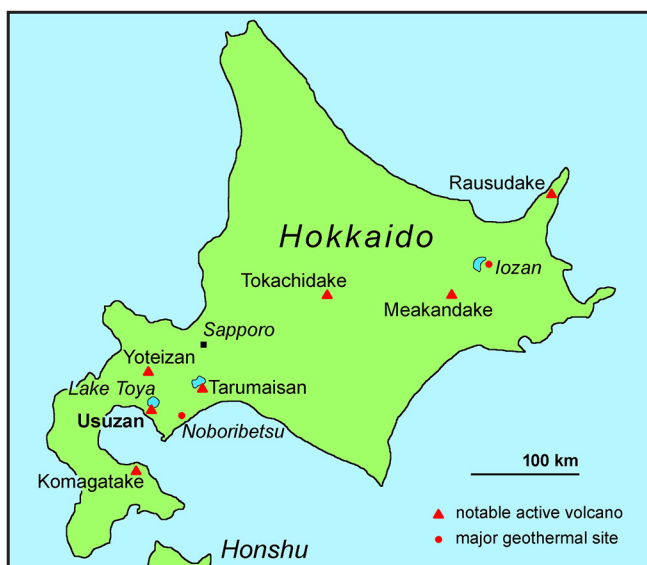
Figure 1. Notable volcanoes and geothermal sites on Hokkaido.

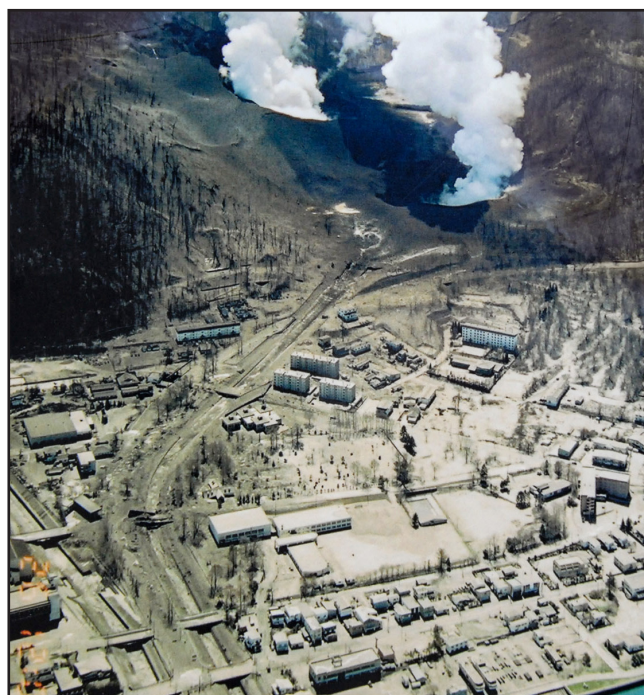
Figure 3. Toyako during the late stage of the Konpira eruptions when only steam was emerging from the two vents. The lahar had already occurred, and the displaced bridge deck can be seen (see map Figure 4) (photo: Toyako Museum).

In April of 2000, a cluster of new vents blasted into activity on the lower flank of the Konpira dome (Fig. 3). The eruptions were preceded by hundreds of minor earthquakes, which had prompted complete evacuation of Toyako, with nearly 10,000 people displaced for some weeks. Phreatic eruptions produced columns of steam and ash up to 2000 metres tall, and included a few small pyroclastic surges that did not reach as far as the houses of Toyako. Most of the airfall ash extended to the east, over Usuzan, and Toyako received only a light covering. The eruptions also built new scoria cones (or cinder cones), each to heights around 30 metres, before activity reduced after a few weeks to steady steam emissions.

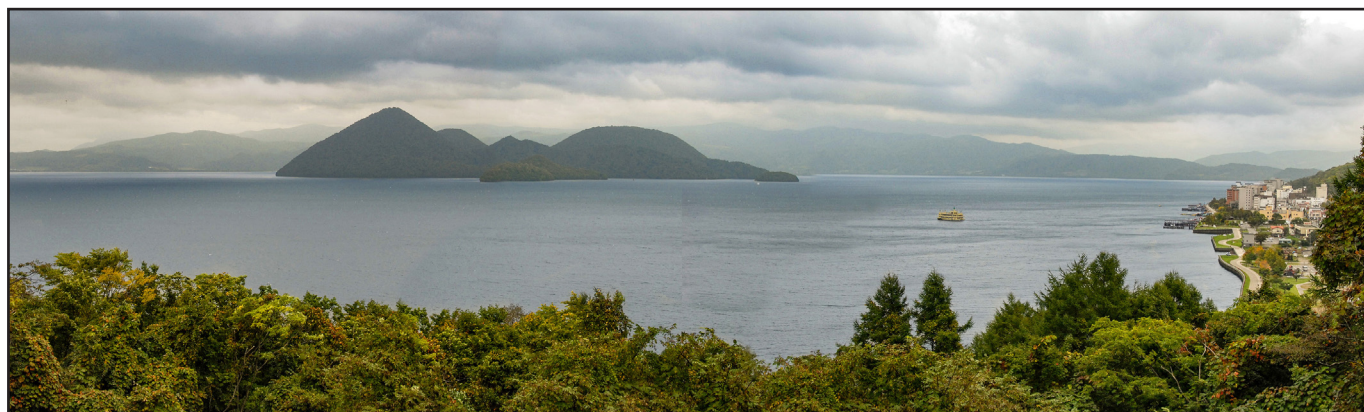
Figure 2. Caldera of Lake Toya, with its central island of newer domes and cones, and the town of Toyako on the extreme right.

The Usu volcano stands near the edge of Lake Toya, which lies in a caldera formed at around 110 ka, and has a central island formed by a cluster of later lava domes and cones (Fig. 2). The edifice of Usu dates back no more than about 30 ka, and subsequently it suffered a lateral collapse of its south-western flank around 8000 years ago; this yielded a huge debris flow that extended to and beyond the Pacific coast. The shoreline is currently five kilometres from the volcano's summit, and the intervening lowland has the numerous large and small

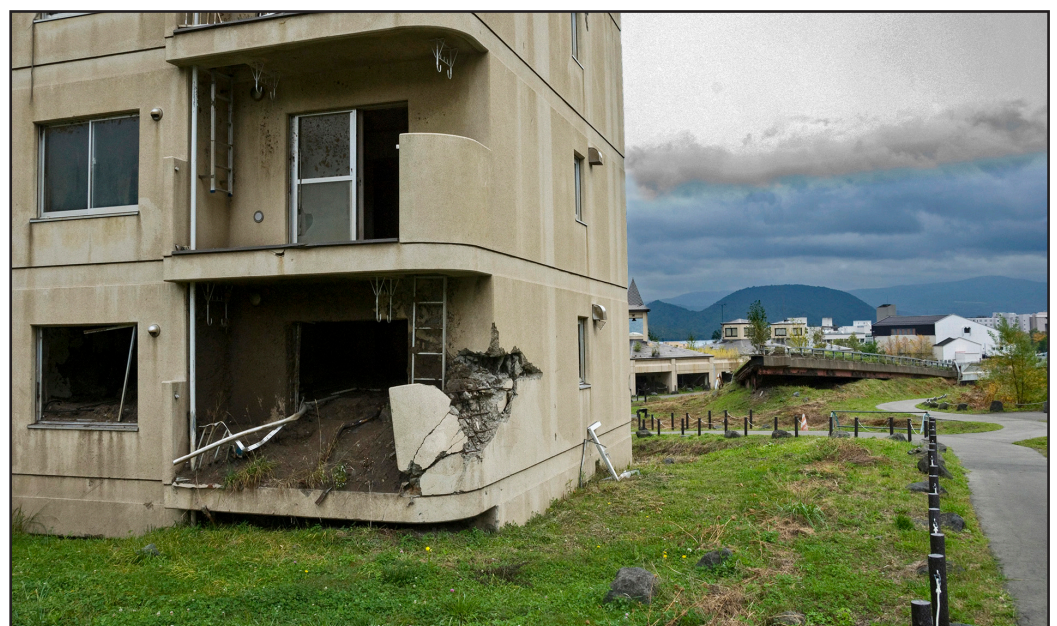
Figure 5. The corner of the one remaining block of the Saguragaoka apartments, with the ground-floor flats almost buried and the upstairs balcony that was hit by the bridge carried down by the lahar; the bridge deck can be seen on the right, where it came to rest, on a mound of debris just beyond the footpaths.

Drama was heightened when the swelling lahar lifted the steel-and-concrete deck of a road-bridge from its abutments and carried it downstream for nearly 160 metres before it came to rest just short of the onsen block. But on its way it had crashed into the corner of the uppermost apartment block. Because the bridge was floating on the dense material of the lahar, it was more than three metres above the original ground level. The ground-floor apartments were already filled with debris, and the bridge hit the balcony of the corner apartment on the first floor, causing significant damage as it passed by (Fig. 5). One can relish the thought of completing the form for an insurance claim.

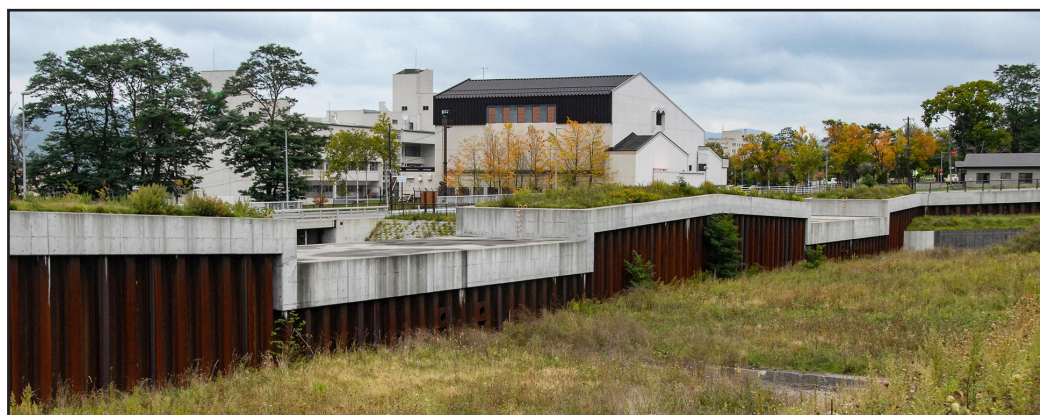
Figure 6. One of the lahar catch dams built after the 2000 event.

preventing damage to the lower town. These barriers were constructed as pairs of sheet-pile walls with the space between filled with locally sourced tephra and then capped with concrete (Fig. 6). These were easier to build than solid concrete structures that would have been difficult to found within the deep cover of weak, ash-rich soils that distinguish the flanks of the volcano. There are two main catch dams across the lower slope of Konpirayama, and also three smaller barriers that will be able to contain terraces on the sloping ground. Two of the apartment blocks have been demolished, along with various other smaller buildings that were damaged or half-buried by the 2000 lahar.

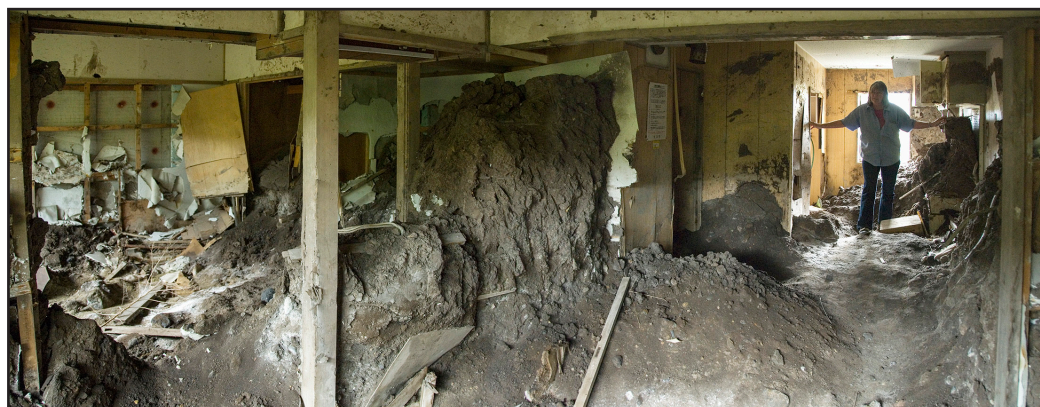
Figure 7. Rooms choked with lahar debris inside the Saguragaoka block that has been preserved.

having educational value in showing how homes can be filled with lahar debris that then consolidates into very resistant material (Fig. 7). Nearby, the offending bridge deck remains where it was finally dumped by the waning lahar. Balcony and bridge combine to make an impressive site.

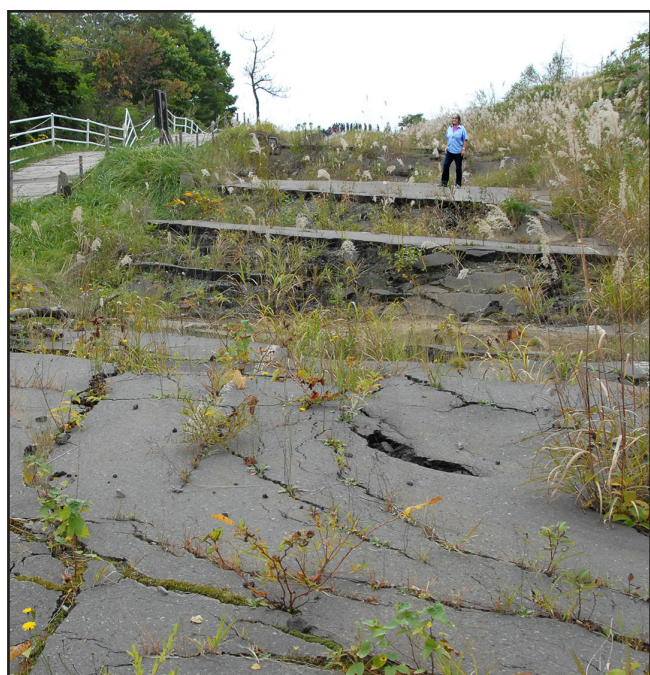
Figure 8. An old road broken by a series of fault scarps that developed during growth of the Nishiyama cryptodome.

A longer trail continues up the hill to the two new Konpira craters, and onwards to link to the Nishiyama Craters Trail, which is also accessible from a road-head further west. This trail follows a section of old road broken by a succession of fault scarps that developed during growth of the cryptodome in 2000 (Fig. 8). It also loops round a dozen or so small craters and cinder cones that still emanate steam, but no longer eject solid material (Fig. 9), besides passing some buildings that were deformed on a spectacular scale by the cryptodome's ground movements.

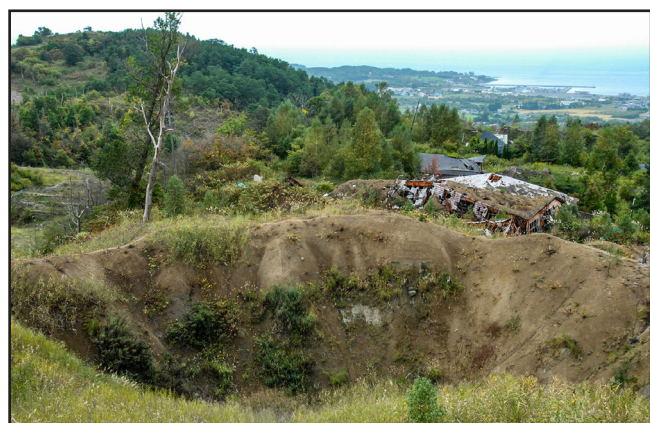
Figure 9. One of the new craters on Nishiyama, beside a school that was wrecked by ground movements during growth of the cryptodome.
