Difficult ground conditions at the Panama Canal

Tony Waltham

Abstract: Construction of the Panama Canal ranks high among the world's greatest feats of civil engineering. It included the world's largest earth dam (at the time) and concrete structures that are among the largest anywhere. The site is also remarkable for the dreadful geology that generated massive landslides during excavation of the Culebra Cut through the high ground.

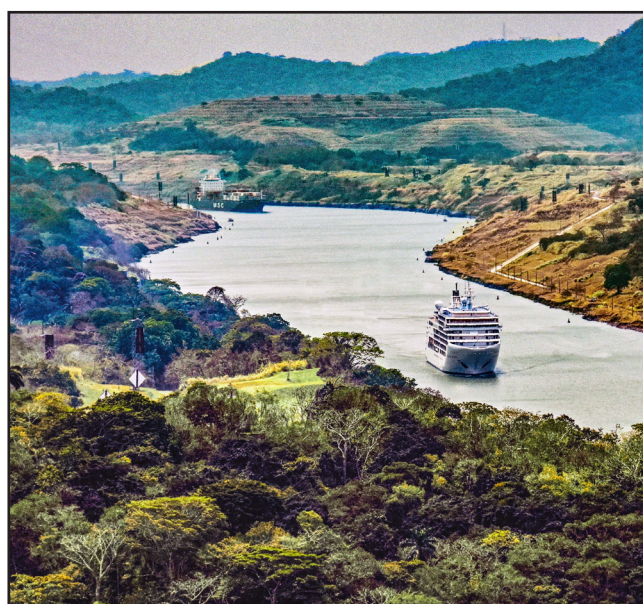
Figure 1. Panama Canal in the excavated section between the Culebra Cut and Gamboa.

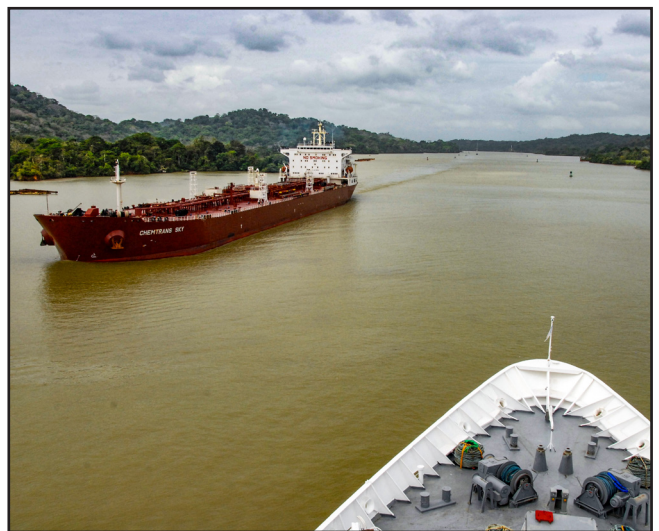
Figure 3. Ships passing each other in the Chagres valley west of Gamboa, where it was inundated by the waters of Gatun Lake.

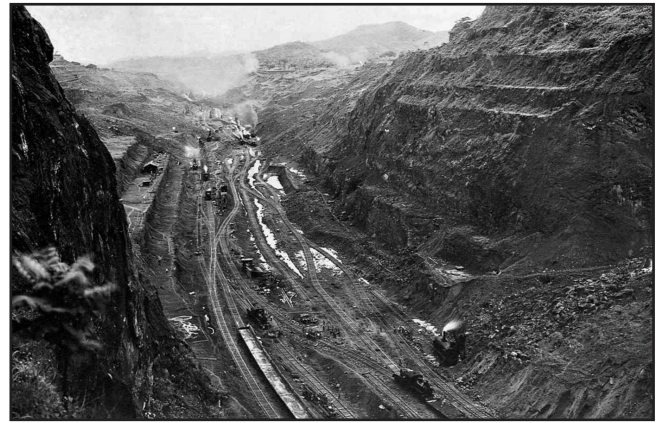
Figure 6. Excavations in the Culebra Cut during 1913, looking north from Contractors' Hill, with rock terraces in Gold Hill on the right, the toe of the Cucaracha Slide lower right, and the lower slopes of the West and East Culebra Slides in the distance (photo: U.S. National Archives).

Between a crest altitude of 107 metres on the watershed divide and a canal floor level of 12 metres, excavation of the Culebra Cut (also known in the past as the Gaillard Cut) was always going to be a massive undertaking (Fig. 6). For nearly five kilometres of its length, it required excavation down to depths of more than 50 metres below original ground level; maximum depths were more than 100 metres. The original plans called for steep rock walls with a rim width of

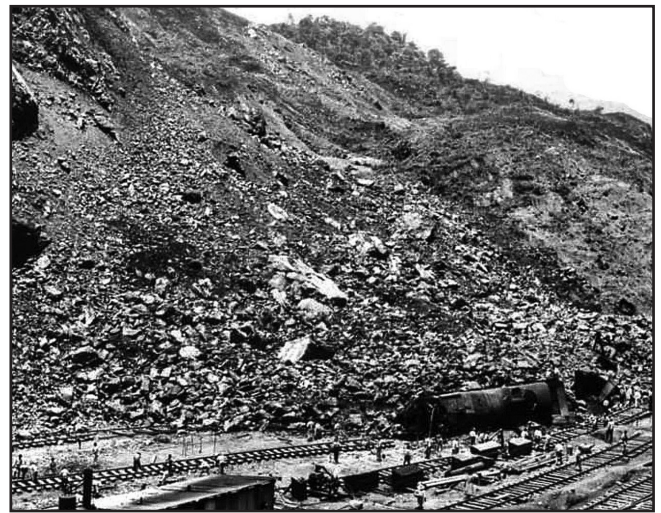
Figure 8. One of the many landslides into the Culebra Cut during the work of excavation (photo: U.S. National Archives)

The walls in the Culebra Cut failed in a spectacular variety of landslide (Fig. 8). Rock falls were numerous and mostly small. Slab failures were larger and mainly developed in stronger volcanic rocks overlying weak clays (Fig. 9). Largest of all were rotational and translational landslides that developed in and above the easily sheared clays. Within the Culebra Cut, critical stages were reached whenever and wherever excavations down through the volcanic rocks and into the underlying Cucaracha clays. This allowed extensive shear surfaces to develop within the clays, and the three largest landslides all crept into activity while engineering works were still in progress (Fig. 10). The faulted and variable sequence of volcanic rocks already had a history of small slope failures, but their generally high strength became irrelevant when they were undermined by failure of the clays beneath. The two Culebra Slides were deep-seated. It appears that the main shear planes at depth developed at least partly along gently dipping bedding planes or within the weakest clays of the Cucaracha Formation. However, uplift at the slide toes was observed when ground rose by as much as ten metres above slip surfaces that curved upwards to the surface. One engineer reported how the floor of the excavations lifted by two metres within about five minutes where it lay on the toe of a rotational slide.

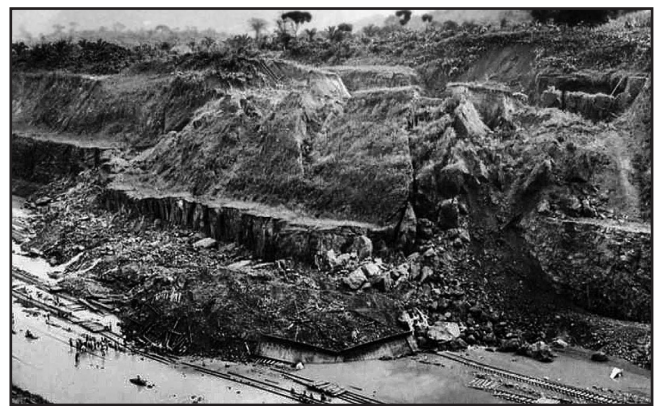
Figure 9. Slab failure into the shallow part of the canal trench between the Culebra Cut and Gamboa. A mass of strong volcanic rock has failed in front of a low-angle oblique fault, and has pushed underlying clay up into the floor of the excavations (photo: U.S. National Archives).

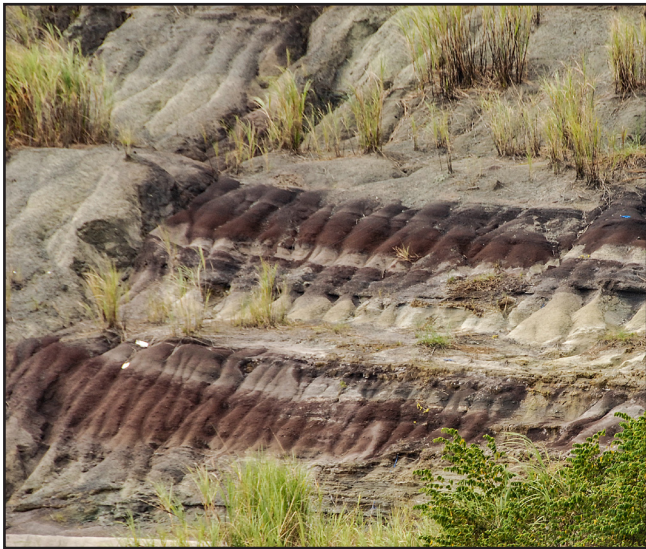
Figure 11. *Cucaracha clay exposed at the edge of the Canal*

Subsequent analyses of clay from the Cucaracha Formation have shown it to be remarkably weak (Fig. 11). It is composed largely of smectite, the weakest of all clay minerals, which is created by weathering of volcanic rocks in hot and wet tropical conditions. Parts of the Cucaracha Formation are recognisable for their pyroclastic content, and it is likely that much of the clay has an ash component, with the rest derived from weathering of the region's older volcanic rocks. With this high smectite content, the internal friction angle of Cucaracha clay has been measured at values as low as 4°, with obvious implications for its stability in slopes.

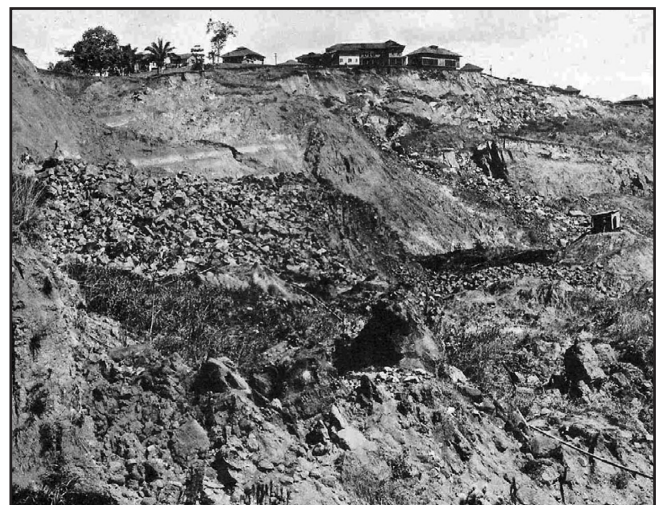
Figure 13. *The West Culebra Slide expanding headwards and progressively undermining the houses of Culebra village (photo: U.S. National Archives).*

Most of the small hill-top town of Culebra was carried away by the West Culebra Slide when its head scarp retreated and enlarged the slide in a series of events (Fig. 13), while the East Culebra Slide developed in the opposite bank. This pair of slides lies in the deepest part of the Culebra Cut, where most of its depth had been laboriously excavated down through the strong volcanic rocks. Both were classic deep-seated slides with larger masses of the hard volcanic rocks moving above slip surfaces within the underlying clay (Fig. 10). In the long term these displaced huge thicknesses of rock and generated more debris to be removed from the advancing toes than did the shallow Cucaracha Slide.

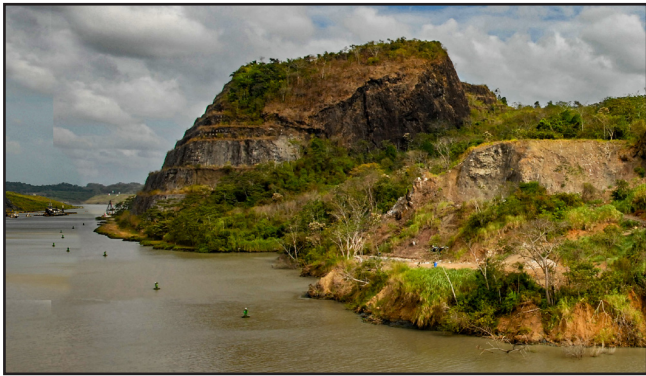
Figure 14. The distinctive terraced rock face on Gold Hill, with the broken ground of the Cucaracha Slide on the right, still creeping into the Canal within the Culebra Cut.

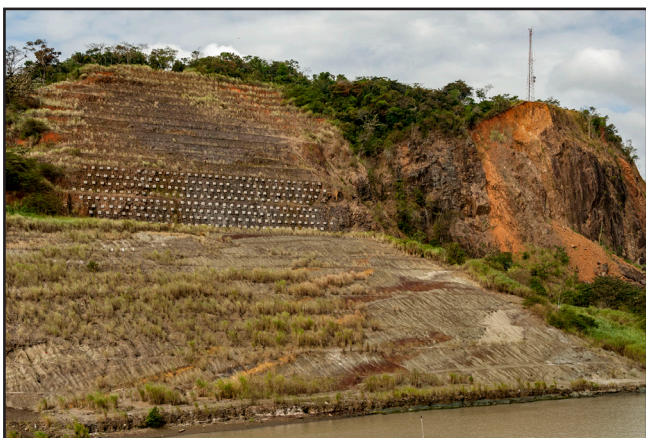
Figure 15. The cut face of Zion Hill in the Culebra Cut; the terraced face in the Pedro Miguel volcanic rocks is constrained by 250 rock anchors to prevent it from sliding out over the underlying Cucaracha Clay that has been cut back to a gentle profile.

Each fault block along the canal has its own geological structure, which may or may not create problems of instability, and significant throws on the cross faults meant that the top of the Cucaracha Formation lies at different levels in each block. Some hills therefore survive with cut faces in strong rock, but these are not necessarily stable. The most conspicuous is Gold Hill (which contains no gold), with its high, benched face forming a well-known landmark along the canal (Fig. 14). It is stable, and the few rock-bolts visible on its faces represent only minor, localised, safety measures. In contrast, the rock spur of Zion Hill, forming the southern flank of the West Culebra Slide, recently started to slide over the underlying clay. Its face was therefore benched, and the whole buttress of volcanic rock is now held intact by an array of long rock-anchors (Fig. 15).

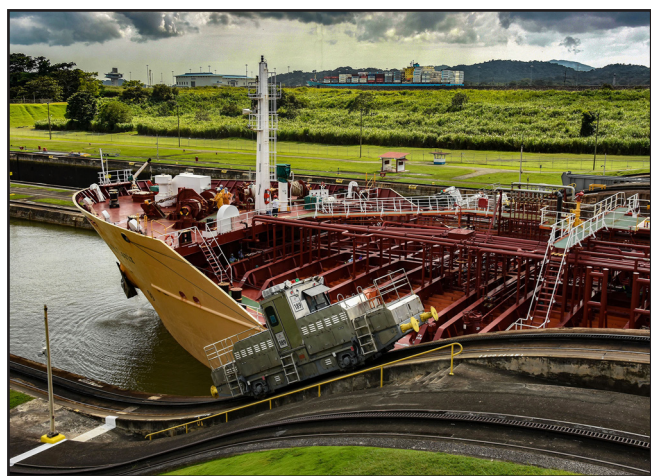
Figure 17. A ship and one of its guiding mules in the Miraflores Locks; in the background, a container ship on its way to the Cocoli Locks is in the high-level canal retained behind the Borinquen earth barrier.

At the Pacific end of the canal, the triple Cocoli Locks represent the upgrade of both the Miraflores and the Pedro Miguel Locks. They lie alongside the Miraflores Locks, so the high-level canal above them passes beside the Miraflores Lake that lies 9 metres below and extends as far as the Pedro Miguel Locks (Fig. 17). The new canal is therefore retained behind the Borinquen dams that total 2300 metres in length long where they overlook the Miraflores Lake (Fig. 18). Effectively forming the canal banks, these dams have a conventional design with a clay core of local surficial residual soils inside a rock-fill that is largely of basalt from the lock excavations. The dams stand on adequately strong sedimentary rocks, but these are broken by the potentially active Pedro Miguel Fault. Field studies and modelling indicated that this could offset by about a metre within the canal's lifetime, but such a displacement can be tolerated within the flexible dam structure. Any accompanying earthquake, up to Magnitude 7, would threaten neither the dams nor the concrete lock structures.
