## Short communication

### Tiankeng flooding in Puerto Rico

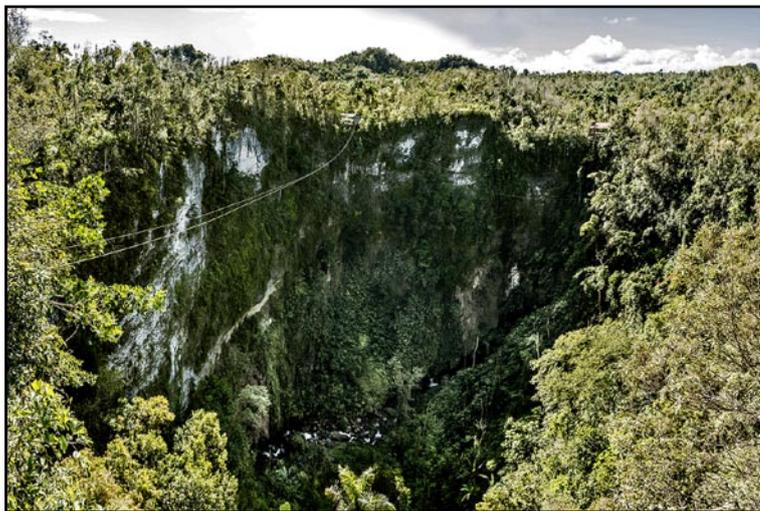
**Figure 1:** The Tres Pueblos tiankeng, with the Rio Camuy flowing across its floor between large cave entrances.

Las Cavernas del Rio Camuy is a major cave system in the heart of the spectacular fengcong cone karst that extends over a large part of northwestern Puerto Rico. The cave includes a series of large, abandoned, high-level galleries and also large, active, low-level streamways linking river sinks to the main rising; known passages total around 15km in length (though local tourist information makes bizarre claims of it being the third largest cave in the world!). Midway along the Camuy caves, the Tres Pueblos doline is some 180 metres in diameter with vertical perimeter walls that reach to 120 metres in depth. It qualifies as being a tiankeng, and has the Rio Camuy flowing across its floor (Fig.1).

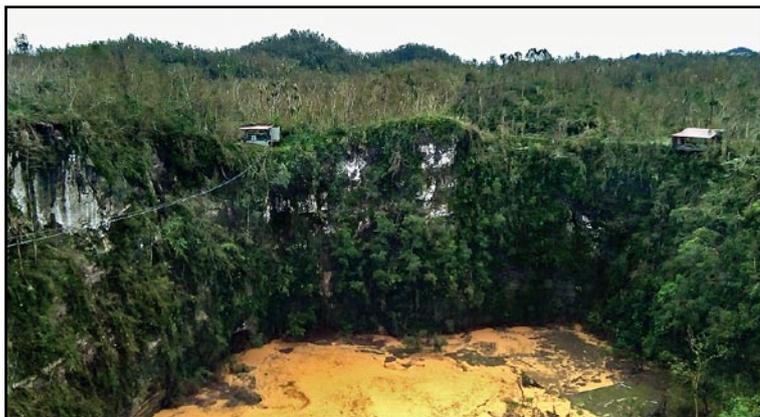
**Figure 2:** The Tres Pueblos site when flooded following the rainfall deluge associated with Hurricane Maria. (Photo: Juan Toledo.)

During Hurricane Maria, more than 250mm of rain was dumped on the entire Camuy catchment within less than 48 hours. The result was flooding on a scale that may be unprecedented since the caves were explored by Russ Gurnee and friends in the 1960s. Details of the Maria flooding are not readily available, but a photograph records the Tres Pueblos tiankeng when it was more than half full of water (Fig.2). It appears that the water was around 60 metres deep, backed up behind narrows in the active streamway and overflowing through some of the normally dry high-level caves. Superimposition of the two photographs better depicts the scale of the flooding in the tiankeng (Fig.3).

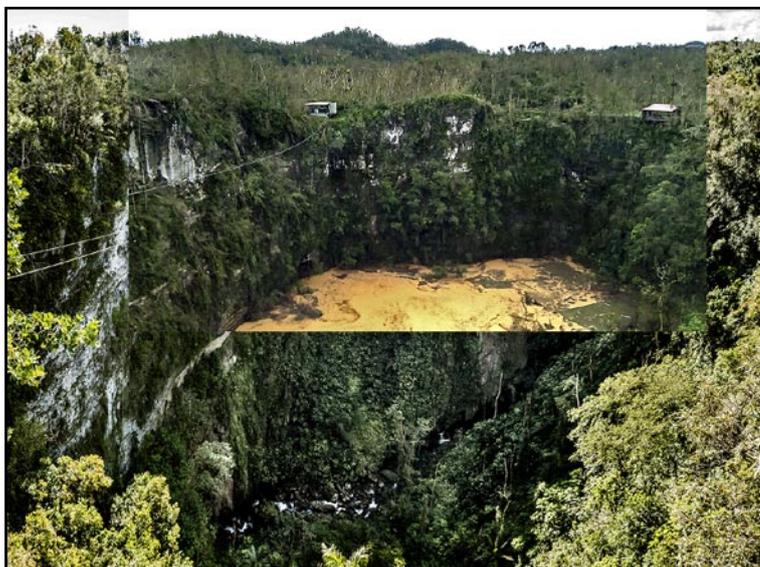
**Figure 3:** The scale of flooding at Tres Pueblos, visualized by superimposing the Figure 2 photograph on Figure 1.
